TREC REI 7-6 PROPERTY INSPECTION REPORT

6200 Classic Avenue Arlington, TX 76017

Dolly Classic Name of Client 6200 Classic Avenue, Arlington, TX 76017	05/12/2025 2:00 pm Date of Inspection		
Address of Inspected Property			
Paul Van Zandt	TREC #23994		
Name of Inspector	TREC License #		
Name of Sponsor (if applicable)	TREC License #

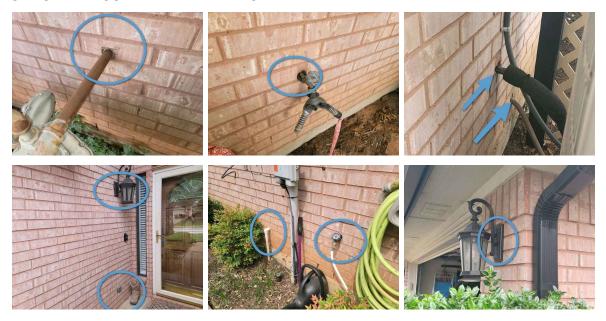
There are exterior wall penetrations that are not sealed. The penetrations should be sealed with an exterior grade paint to help prevent moisture and / or pest intrusion in those areas.
